Research Article

El Kalaeet - El Foula Area Cracks in the West Kordofan State, Sudan: Environmental Impacts and Geological Hazards

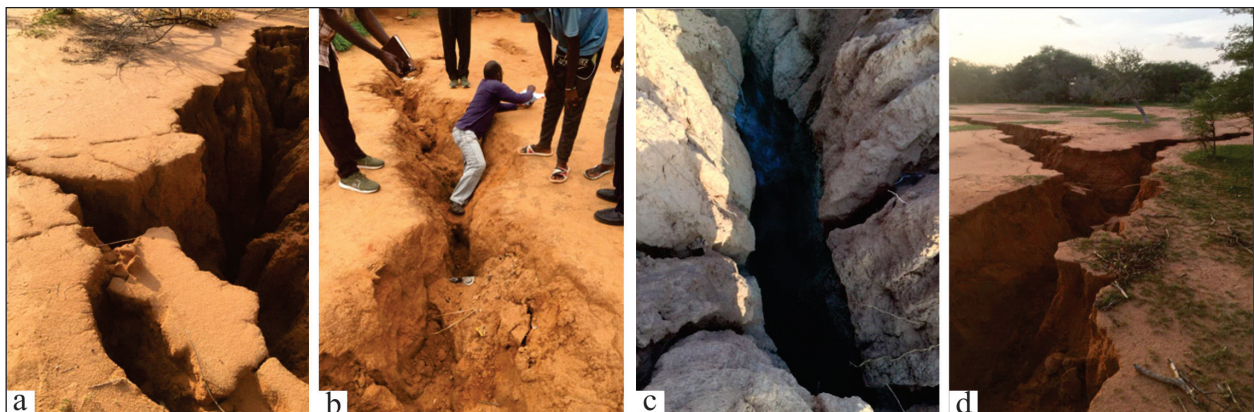
The field observations could be discussed through main points; the apparent depth of these cracks and fissures reached up to 6 meters and no (vertical or horizontal) movements were observed in the field affected by the cracking processes. Most of the cracks in many parts are very extensive (similar to digging processes) due to the

collapse of these cracks and their descent down through the crack zone (Figure 3). Majority of the investigated cracks were characterized by triangular forms (Figure 2 and 4), with different angles directions, and with a proximately north to south orientation (Figure 2). Cracks and fissures located in the southernmost part of the affected area were having water up to depth of 1.5 m from the surface of the earth (Figure 5). It is worth mentioning that this water is the rainfall water before the trip day, and this fall is the first fall came after the precipitation that resulted in the aftermath of those cracks. The exposed layers across the virtual depth are two layers; A top layer with a thickness of up to three meters, consisting of weak red sand, which is considered to be the wind sediment of the origin (sedimentation). An undersea layer of fish, who's open, reached to three meters thickness. This layer consists mostly of soft sand, with some nodes consisting of oxides (iron oxide), incoherent, mostly gray with the presence of colors after the green, yellow, red and other in the form of sporadic spots caused by climatic and natural changes following its deposition period in what was known as Mottling's geology.

Figure 3. Cracks in many Parts displaying Collapses and their descent Down through the Crack Zone

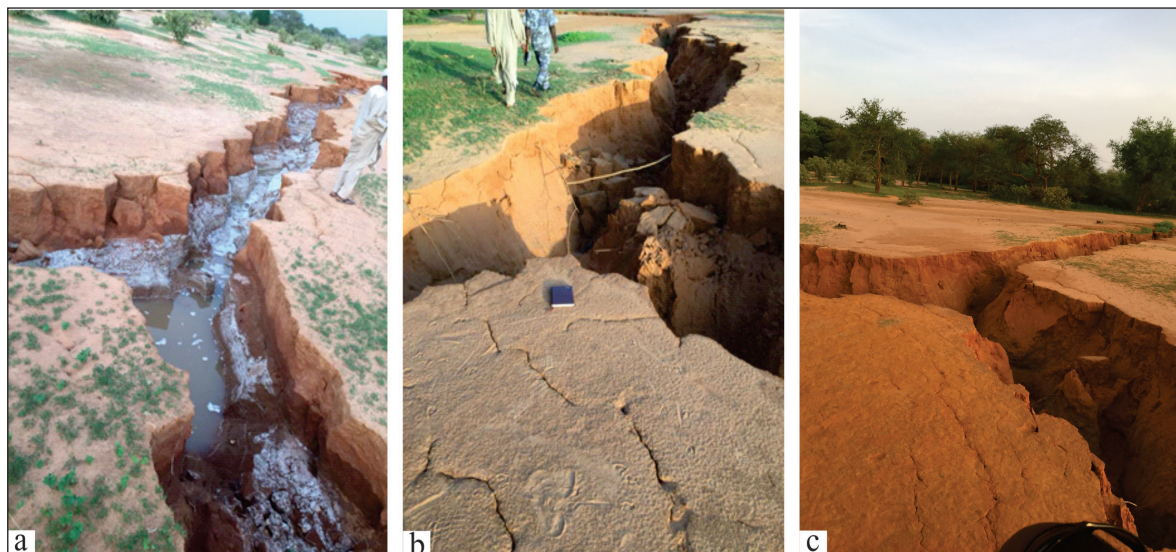
Figure 4. The Investigated Cracks Showing Triangular Forms

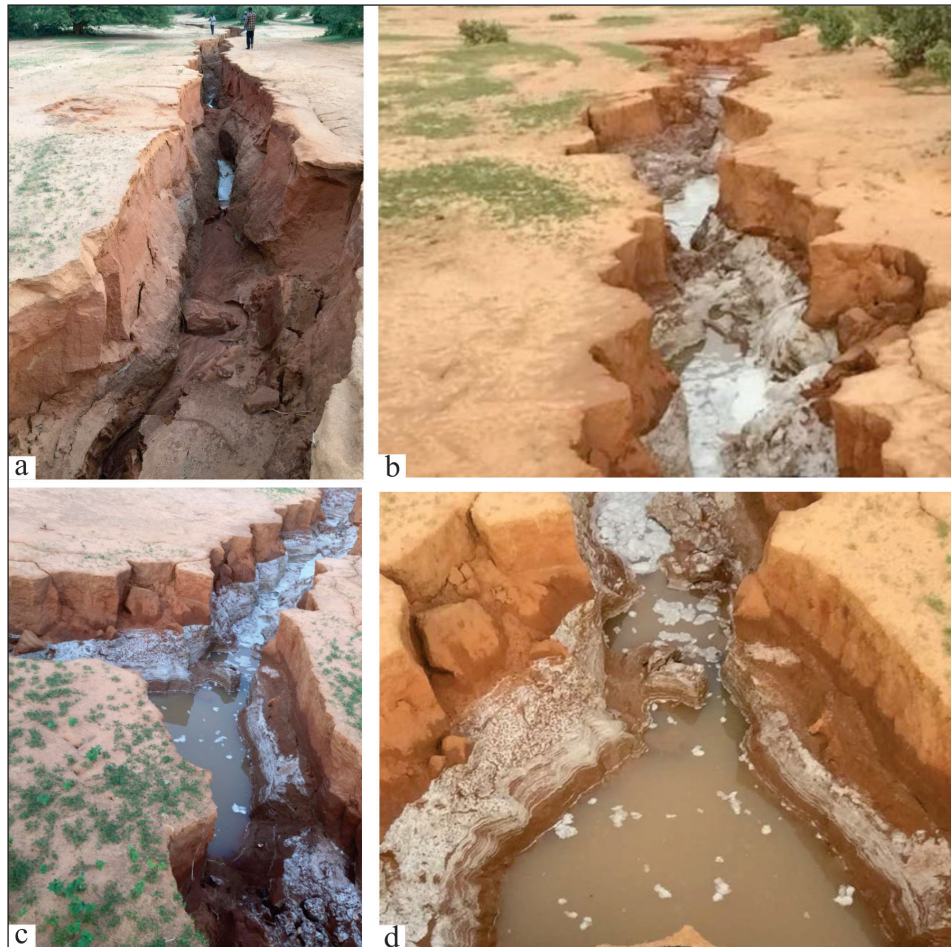
Figure 5. Cracks and Fissures Containing Water

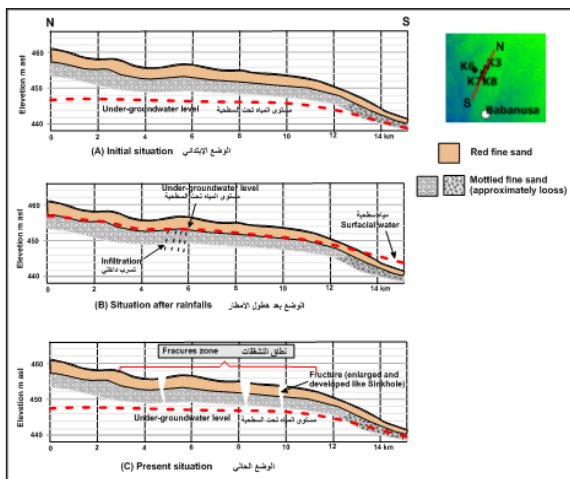
materials are originally disassembled, the lattice ranges widen with the vertical and horizontal water movement. Fourthly As a result of the internal leakage and horizontal movement of the water, there will be soon drop in the water level below the diameter so that the two layers again will above the water level of the under groundwater. Fifthly Because of the tow affected layers are in general unconsolidated materials, especially the red top layer; cracking processes will occur on the sides of the cracks zones to trap the rundown materials down through these zones. The cracking zones will therefore widen to give a grafted pattern (bases to the down). Lastly these conical holes are very similar to the so-called sinkhole drills, which are formed in limestone places where melting of calcareous materials occurs if they are saturated or flooded (Kaufmann, 2007; Alrowaimi, 2016; Alrowaimi, et al., 2016).

Figure 6. Explains what Happened in the Area During These Phenomena
